Prepared For Department of Water Resources
Project Non-Urban Levee Evaluations Project
Contract 4600008101, Task Order U115
Date June 2, 2014
Subject Risk Analyses of Burrowing Mammal Activities in State Plan of Flood Control Systems
Prepared By Sujana Punyamurthula, PhD, PE, Nagesh Malyala, PE, and Brian Boen, PE
Reviewed By Joseph Barnes, PE, Tom Trexler, M.S

INTRODUCTION

This technical memorandum (TM) evaluates the impact of burrowing animals on the geotechnical performance of levees. This TM is prepared in compliance with Task Order U115's Task 1 scope of work, dated November 8, 2013, under Master Agreement 4600008101.

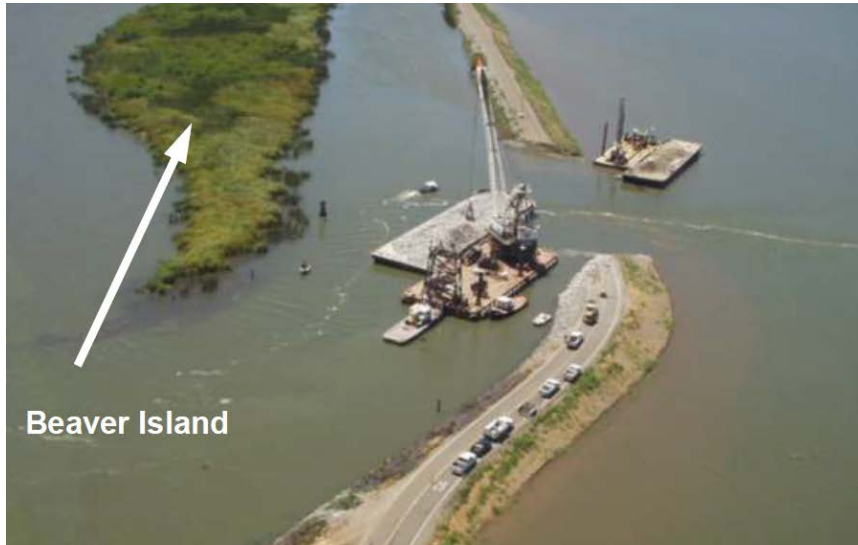
Post-breach seepage analysis performed by engineering consultants HDR Inc. supports the likelihood that the breach occurred due to burrowing animal activity. After the breach, seepage analysis was performed at two locations: the breach site and a site located north of the breach site with historical seepage boils. The seepage analysis results indicated a higher gradient at the site located north of the breach. Therefore, an underseepage breach would have been more likely to have happened at the site to the north were it not for burrowing animal activity lowering the resistance causing failure.

This conclusion is supported because beaver activity was prevalent in the area and there was a large population of beavers on Beaver Island, which is adjacent to the Middle River levee's waterside slope. There was also beaver population noted in a landside canal approximately 750 feet upstream of the breach site. No data is available about the size or extent of animal burrowing at this location, as the levee breach washed away evidence. Figure 4 shows a photograph of the levee breach.

Figure 4. Levee Breach along Middle River in Upper Jones Tract.

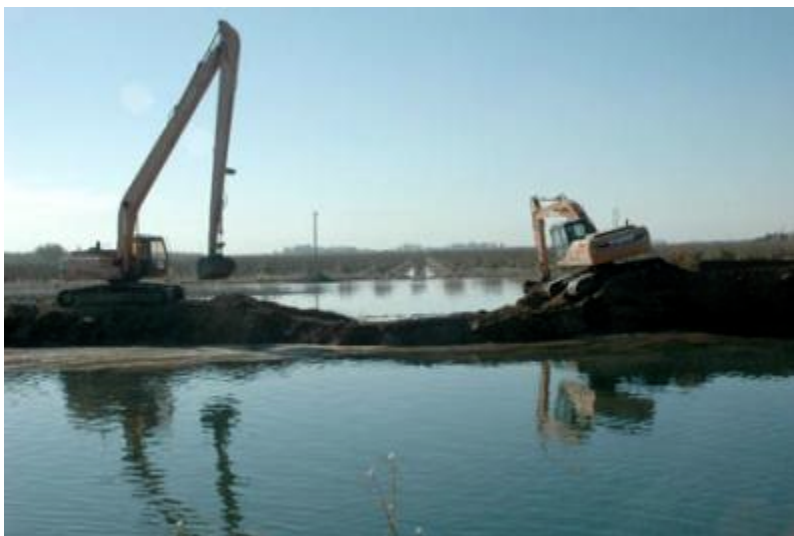
A canal embankment failed near Ord Bend on October 22, 2013. Ord Bend is located just south of County Road 29, about a mile west of Highway 45 in Glenn County, California. The breach was approximately 25 feet wide and reached a depth of 6 to 8 feet below crest (the embankment is approximately 12 feet high) (Figure 6).

At the time of the failure, Glenn-Colusa Irrigation District Communications Director, Cynthia Davis, stated that the likely cause was due to a gopher hole. At the location of the breach there is an orchard on the landside of the embankment. There are no data available about the size or extent of animal burrowing at this location, as the levee breached and evidence was washed away.

Figure 6. Levee Breach along Glenn-Colusa Canal near Ord Bend.

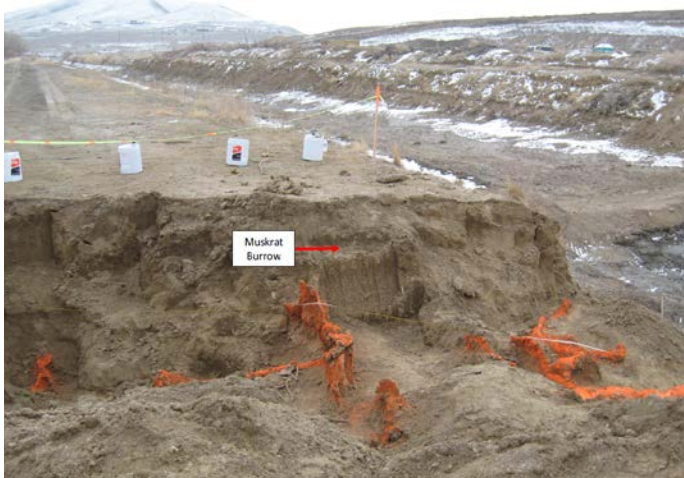
Further analysis was performed at a section of embankment near the breach site shown in Figure 7. Several cracks were observed that parallel the embankment. Stratathane, an injectable two-component urethane, was injected into several burrows, and the embankment was carefully excavated. The excavation revealed several burrow tunnels made by muskrats. One t-shaped burrow was observed to run about 9 feet from the face of the waterside slope into the levee. The burrowing extended from the waterside slope to nearly the landside slope. Truckee-Carson Irrigation District personnel informed the investigation team burrowing animals were highly active in the area, and upon arrival at the scene burrowing animals were observed in the residual water.

Figure 7. Section of Embankment Analyzed and Excavated Near the Truckee Canal Breach at Fernley.

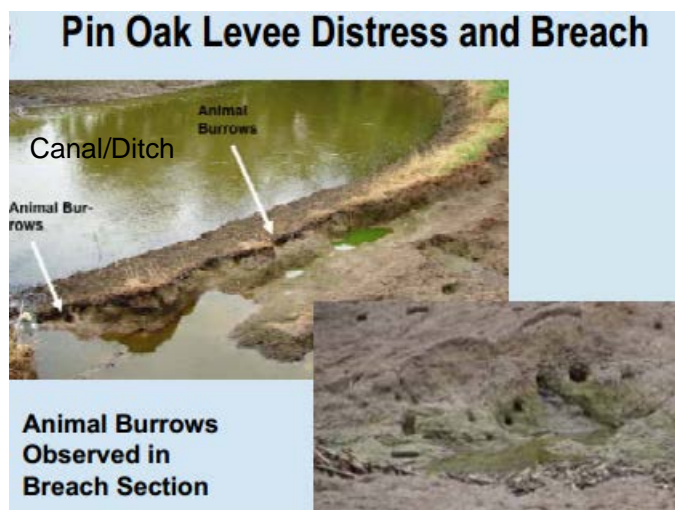
After the breach, 2- to 3-inch-diameter burrow holes were observed along the perimeter of the breach site and there were indications of burrow holes mid-waterside slope near the base of the levee. Both sites were appealing to muskrats because the levee had water-filled ditches/canals. Animal burrows in the breached section of the levee can be seen in Figure 8.

Figure 8. Levee Breach along Pin Oak Levee System.

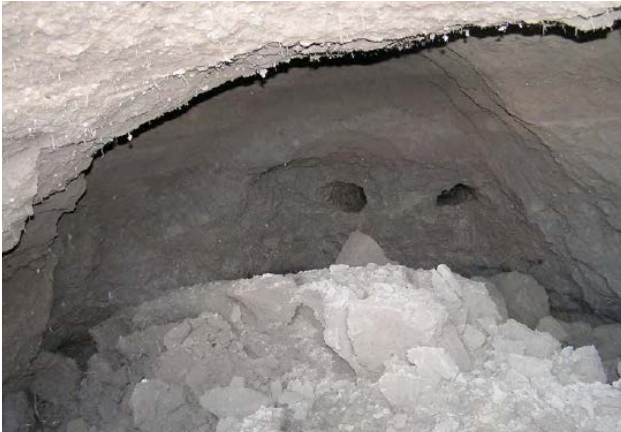
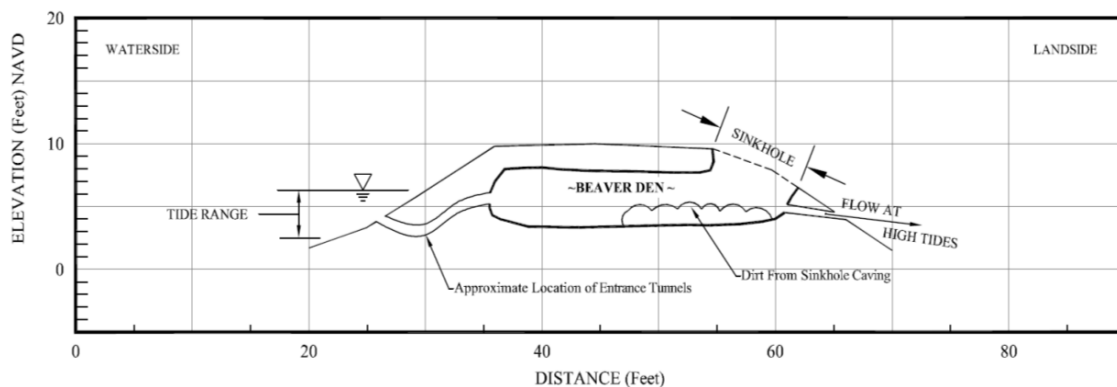
The sinkhole on the landside edge of the crown exposed a large beaver den. The void left by the beaver den was approximately 5 feet high, 9 feet wide and 12 feet across the top of the levee. The thickness of the crown was about 2 feet. Water at high tide was filling the void left by the beaver den and could be seen exiting mid-landside slope. At lower tides, seepage was not occurring, so construction crews had time to collapse the beaver den shown in Figure 9 and backfill the void. Construction crews also observed several beaver dens in the nearby area and repaired those sites as well. Many of the beaver dens were exposed when *Arundo* vegetation was cleared along the waterline.

Figure 9. Profile of Beaver Den and Image of Den along Medford Island.

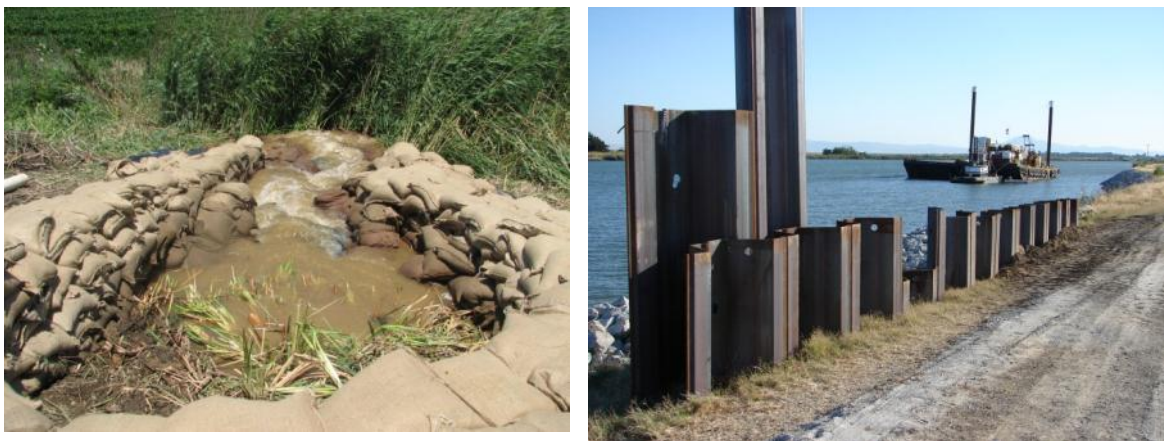
A levee nearly failed on Mokelumne River along Staten Island in June of 2007. The near breach occurred during the summer when there was no rainfall. A large boil was found exiting the landside levee slope near the toe as shown on Figure 11. It was believed that the boil was a result of a collapsed beaver den (Harder, 2013). A barge-mounted crane was brought in to drive sheet piles, and an excavator partially dug out and filled the beaver den. Construction activities were successful in stopping the through seepage.

Figure 11. Sand Bag Ring Around Landside Boil and Sheet Pile Wall along Staten Island Levee to Prevent Near Breach.

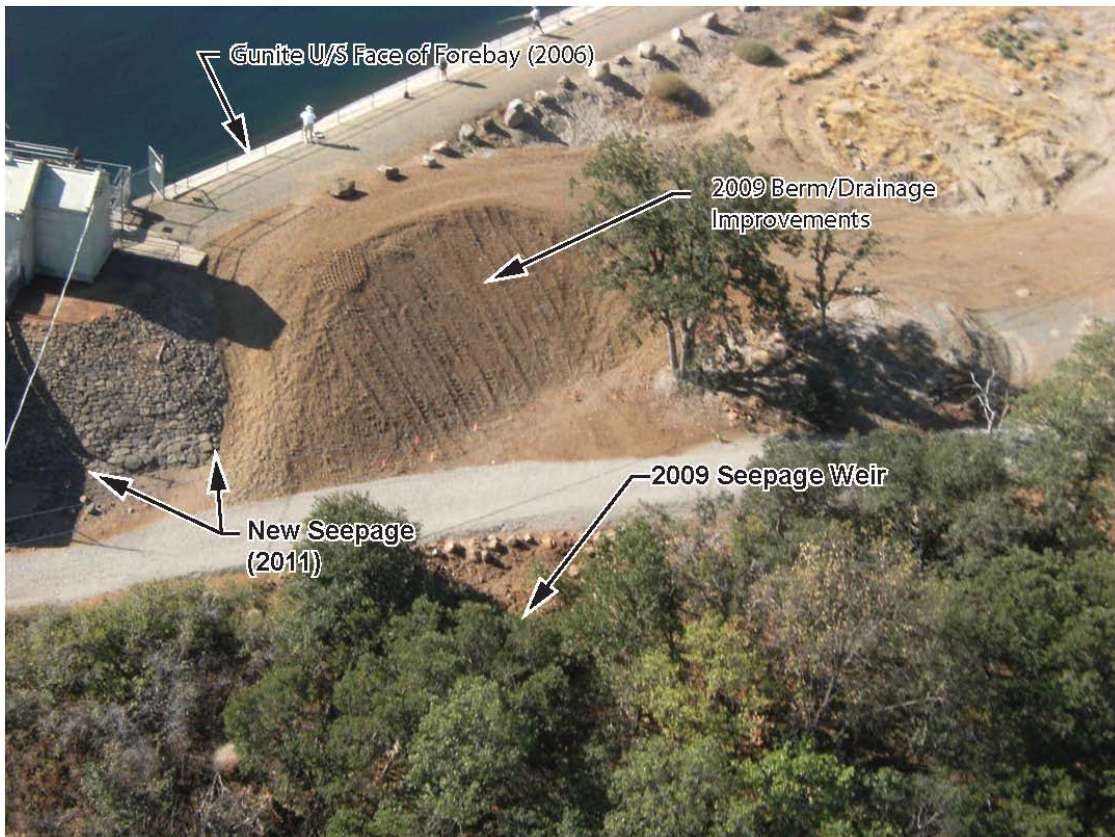
The Hat 1 Forebay is located in Shasta County, about seven miles northeast of Burney, California. The forebay embankment nearly failed on March 14, 2012 when a sinkhole was observed on the crown that was approximately 3.5 feet long and 2 feet wide. The forebay was drained following the observation to prevent a breach. Historically, seepage had occurred in the area several times. Several repair attempts were made prior to the 2012 incident, including construction of a seepage berm shown in Figure 12. The sinkhole was located near the interface of the original embankment and the 2009 repair seepage berm. The seepage increased when the water surface elevation of the forebay was raised by 1 foot. After the forebay was drained, water could be seen emanating from the waterside slope at several locations between new and old shotcrete joints (Bowers et. al).

Cone penetration test soundings were performed and revealed a large void near the sinkhole just below the ground surface. Several holes from the cone penetration test probe could not be filled with grout or required more grout than expected. The sinkhole was backfilled with controlled low strength material (CLSM) and an exploration trench was dug, revealing numerous and extensive burrowing activity in the vicinity. Additionally, burrow openings with diameters as large as 4 inches were observed on the landside of the embankment.

Figure 12. Aerial View of Hat Creek Forebay Embankment Showing History of Repairs.

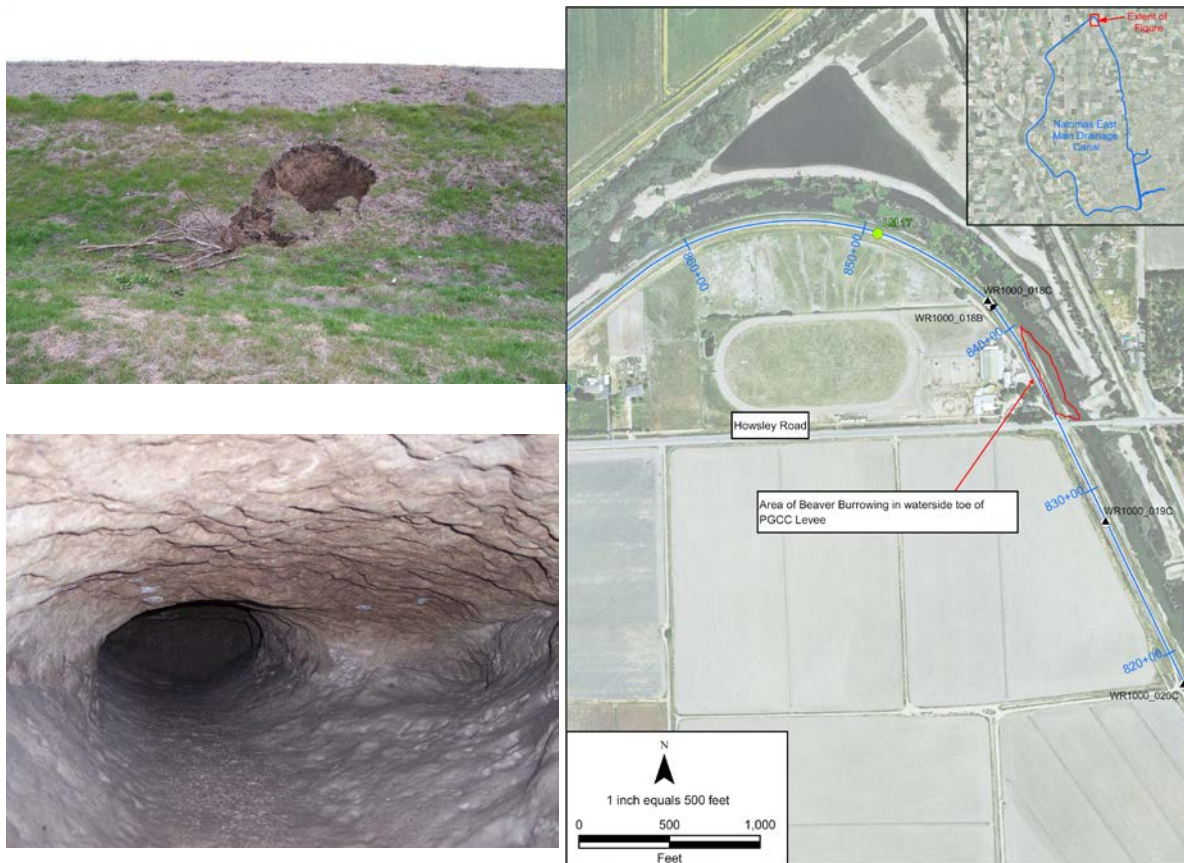
An animal burrow was observed during inspections in January and February of 2008. Collapse features such as depressions and holes were documented along the waterside toe of the PGCC levee north of Howsley Road. These features were documented along an approximately 950 foot long section of levee from Station 830+50 to 840+00 (Figure 13). The levee was repaired prior to a high water event; therefore, no further damage occurred.

The collapse features and holes were associated with numerous 1- to 3-foot diameter tunnels or burrow holes along the waterside toe. The collapse feature extended greater than 10 feet into the levee and appeared to be caused by beaver activity.

Figure 13. Burrowing Activity Observed along Pleasant Grove Creek in Natomas.

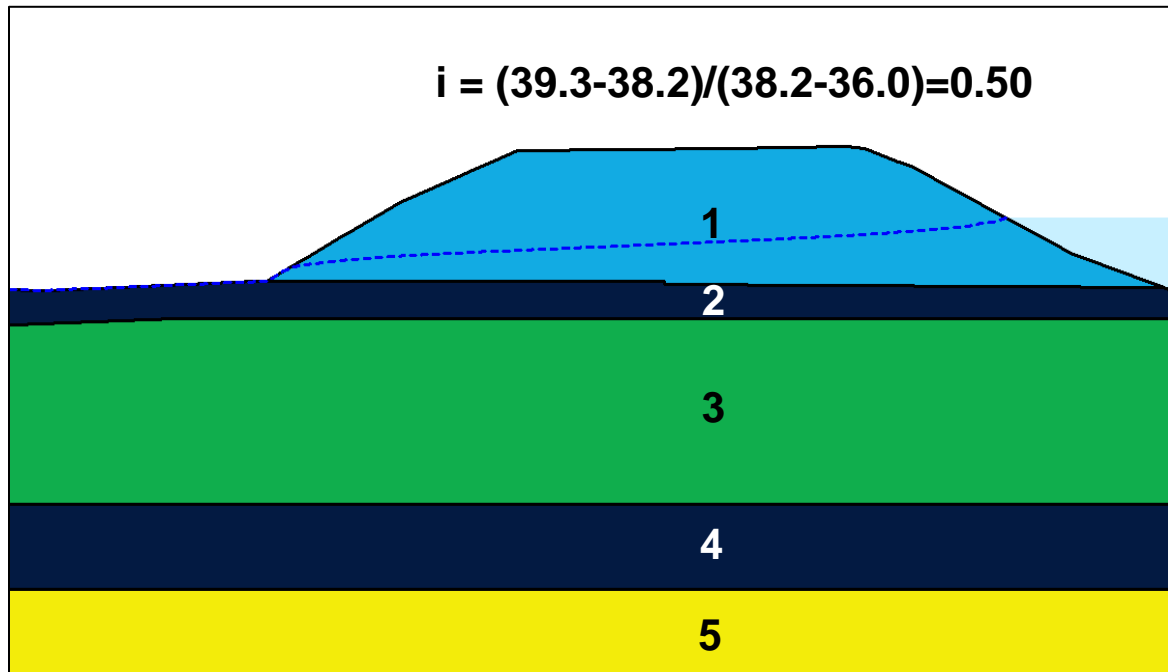
Figure 14. Seepage Analysis Model - No Burrow Holes (Case 1)

- Underseepage analysis performed on the conceptual model resulted in an average vertical exit gradient of 0.5 at the levee toe. The calculated gradient meets criteria of 0.5 for underseepage (Figure 14). Potential seepage conditions along landside toe would initiate at gradient of above 0.5 and potential piping at a gradient of 0.8.
- Landside stability analysis resulted in a factor of safety (FOS) of 1.74. The calculated FOS meets criteria of 1.4 for stability (Figure 15).
- Analysis results indicate the through seepage phreatic surface breakout point approximately 0.6 feet above the levee toe. Since the embankment material at and below the breakout elevation is erodible, the result does not meet criteria for through seepage.

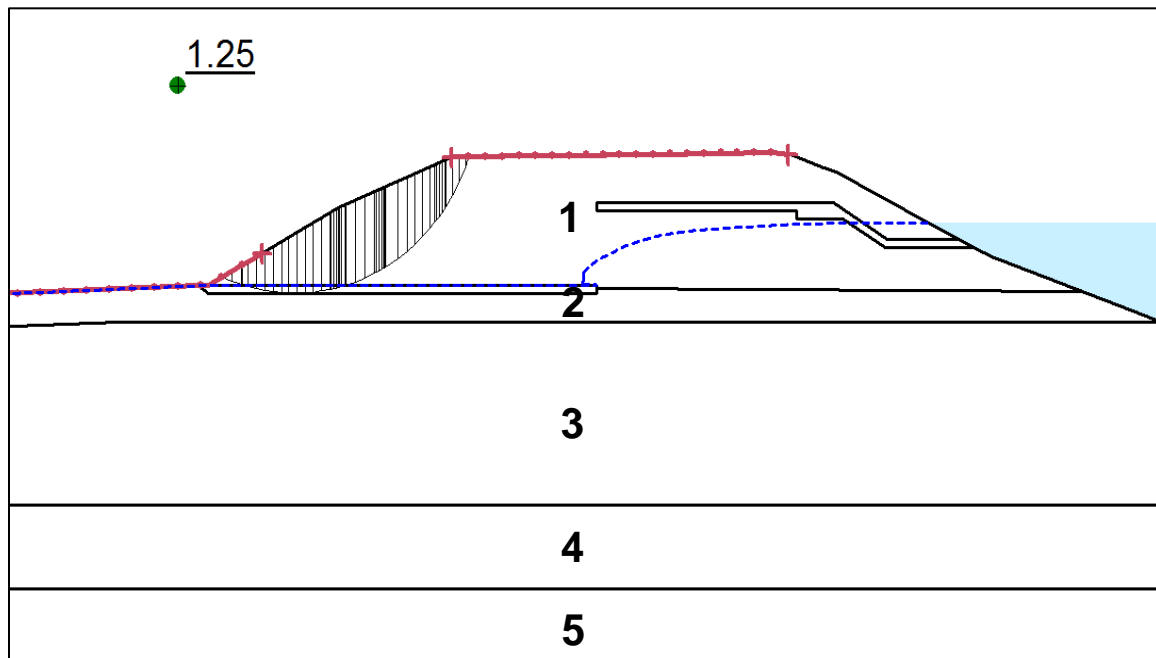
Figure 19. Stability Analysis Model - Waterside Burrow Hole and Landside Burrow Hole at Toe (Case 3)

- The animal burrow modeled at the landside toe resulted in reduced blanket thickness, increasing the underseepage gradient from 0.5 (for no-burrow condition) to 0.76 at the levee toe (for combined landside and waterside burrow conditions). The calculated gradient does not meet criteria of 0.5 for underseepage (Figure 18).
- The factor of safety calculated from steady-state stability analysis was reduced from 1.74 (under a no-burrow condition) to as low as 1.25 (under a waterside and landside burrow condition) (Figure 19).

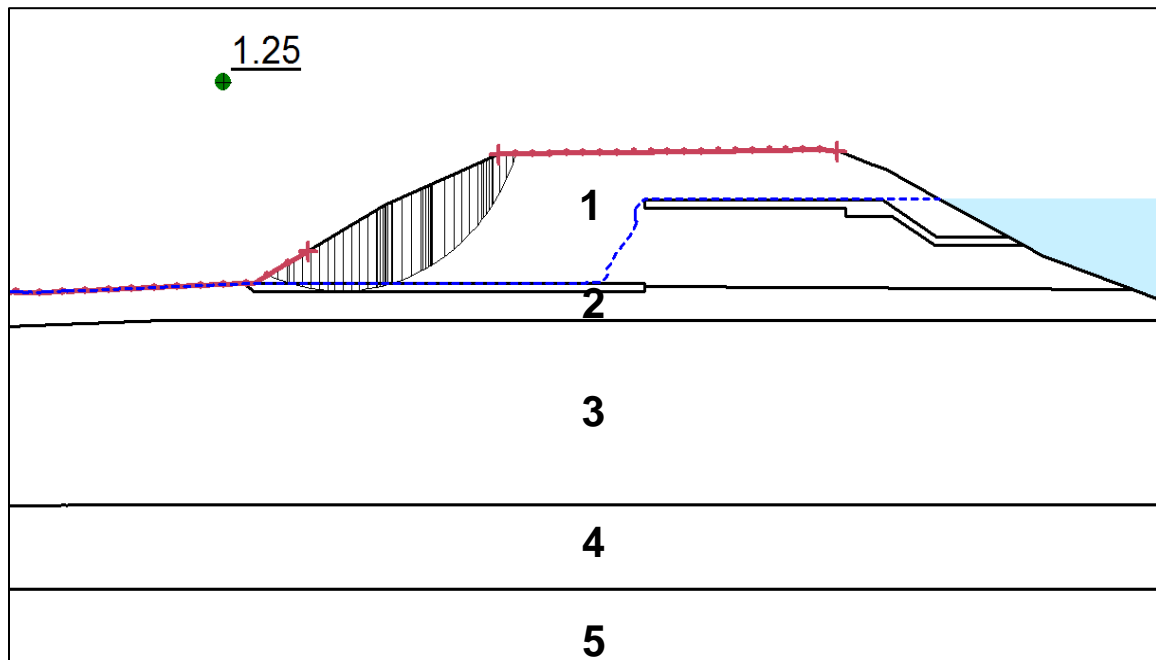
Figure 21. Stability Analysis Model - Waterside Burrow Hole and Landside Burrow Hole at Toe with Water Surface Elevation to Top of Waterside Burrow Hole (Case 4)

- The landside stability analysis on the Case 4 resulted in a factor of safety of 1.25 (Figure 21).
- The presence of animal burrowing activity on a levee (both landside and waterside) results in significant reduction of the seepage path (as observed from phreatic surface), and could result in a piping failure of the levee (i.e., piping potential increases if the levee embankment material is erodible in nature).

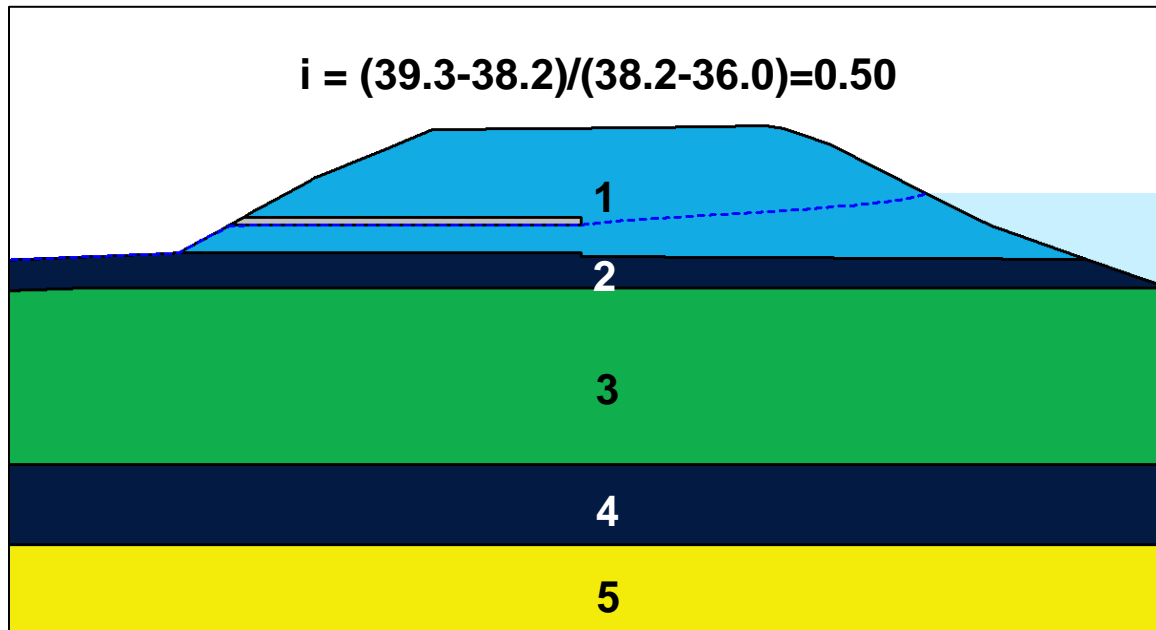
Figure 22. Seepage Analysis Model - Burrow Hole on Landside Slope Located 1.5 ft. Below the Water Surface Elevation (Case 5)

- Underseepage analysis performed on the conceptual model resulted in an average vertical exit gradient of 0.5 at the levee toe. The calculated gradient meets criteria of 0.5 for underseepage (Figure 22).
- The factor of safety calculated from steady-state stability analysis was reduced from 1.74 (under a no-burrow condition) to as low as 1.26 (under a burrow on the landside slope at 1.5 feet below the water surface elevation condition) (Figure 23).
- Additional analysis was performed considering a burrow on the landside slope, located 1.5 feet below the water surface elevation. Seepage analysis performed resulted in increase in the break out point above the landside toe from 0.6 (under a no-burrow condition) to 1.7 feet (under a burrow on the landside slope at 1.5 feet below the water surface elevation condition) due significant reduction in the seepage path(Figure 22).
