Prepared For Department of Water Resources
Project Non-Urban Levee Evaluations Project
Contract 4600008101, Task Order U115
Date June 2, 2014
Subject Risk Analyses of Burrowing Mammal Activities in State Plan of Flood Control Systems
Prepared By Sujana Punyamurthula, PhD, PE, Nagesh Malyala, PE, and Brian Boen, PE
Reviewed By Joseph Barnes, PE, Tom Trexler, M.S

INTRODUCTION

This technical memorandum (TM) evaluates the impact of burrowing animals on the geotechnical performance of levees. This TM is prepared in compliance with Task Order U115's Task 1 scope of work, dated November 8, 2013, under Master Agreement 4600008101.

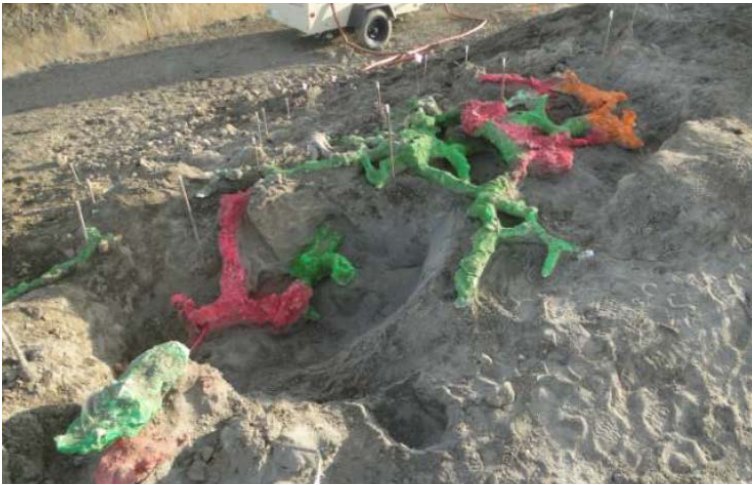
Figure 2. Photo Showing Investigation of Animal Burrowing Activity.

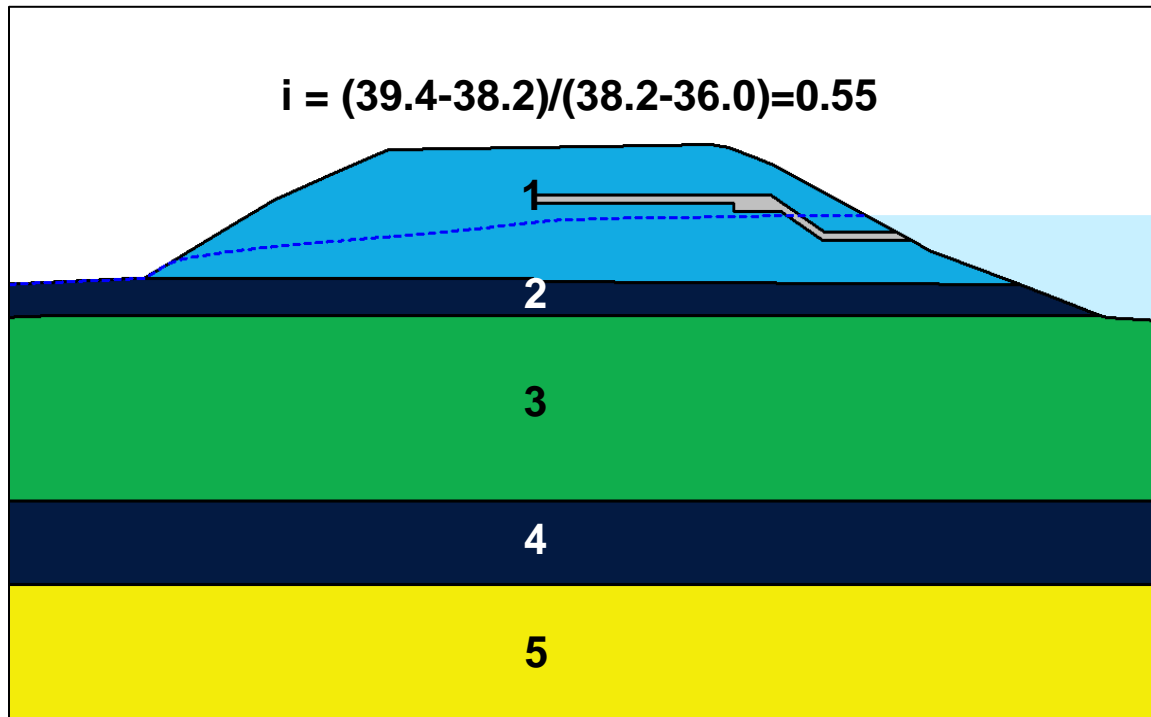
Figure 16. Seepage Analysis Model - Waterside Burrow Hole (Case 2)

- Underseepage analysis performed on the conceptual model with animal burrow on the waterside slope, resulted in slight increase in the average vertical exit gradient from 0.5 (for no burrow condition) to 0.55 at the landside levee toe (for the waterside burrow condition). The calculated gradient does not meet criteria of 0.5 for underseepage (Figure 16).
- The factor of safety from the landside stability analysis decreased from 1.74 (for no burrow condition) to 1.70 (for waterside burrow condition). The calculated FOS meets criteria of 1.4 for stability (Figure 17).
- The phreatic surface break out point is approximately 0.6 feet above the levee toe in erodible material. The result does not meet criteria for through seepage.

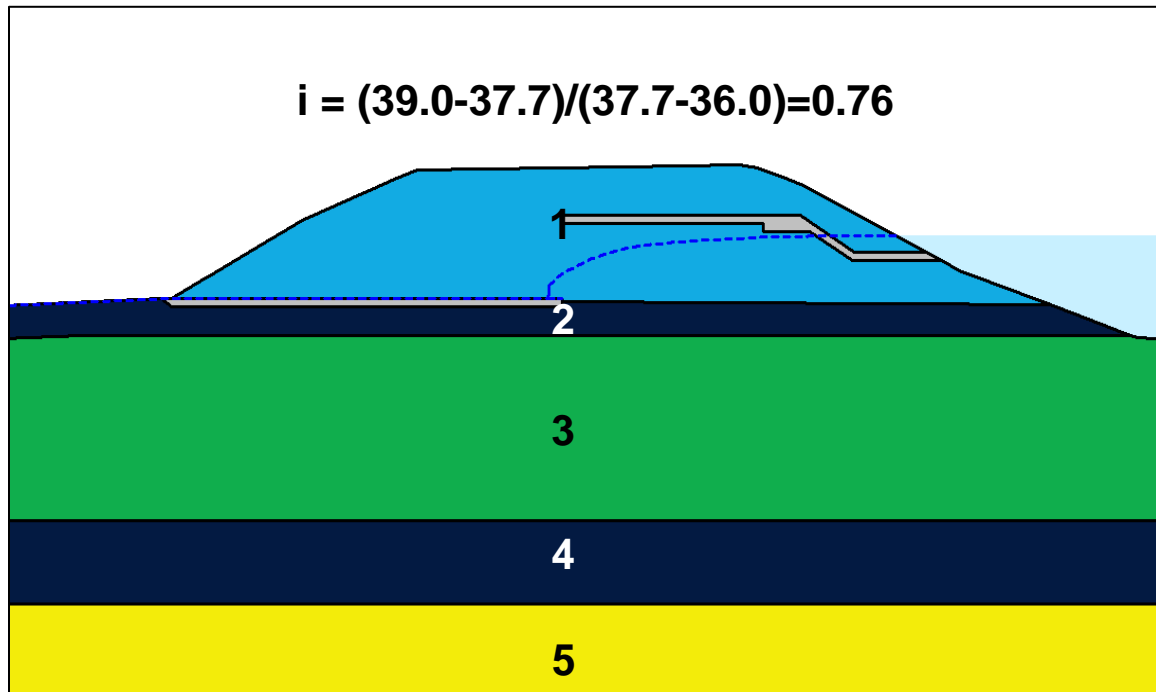
Figure 18. Seepage Analysis Model - Waterside Burrow Hole and Landside Burrow Hole at Toe (Case 3)

- The animal burrow modeled at the landside toe resulted in reduced blanket thickness, increasing the underseepage gradient from 0.5 (for no-burrow condition) to 0.76 at the levee toe (for combined landside and waterside burrow conditions). The calculated gradient does not meet criteria of 0.5 for underseepage (Figure 18).
- The factor of safety calculated from steady-state stability analysis was reduced from 1.74 (under a no-burrow condition) to as low as 1.25 (under a waterside and landside burrow condition) (Figure 19).

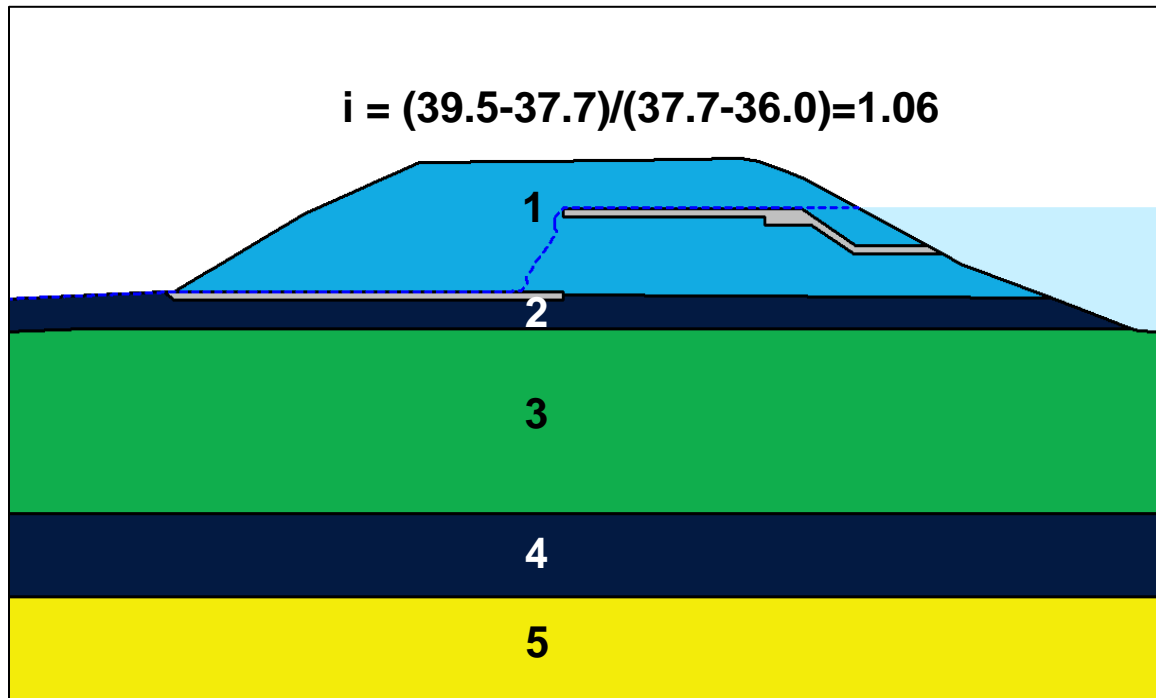
Figure 20. Seepage Analysis Model - Waterside Burrow Hole and Landside Burrow Hole at Toe with Water Surface Elevation to Top of Waterside Burrow Hole (Case 4)

- Additional underseepage sensitivity performed on the Case 3 model increasing the WSE by 1.3 feet (so that waterside burrow is submerged under water) resulted in increase of average vertical exit gradient from 0.76 to 1.06 (Figure 20).

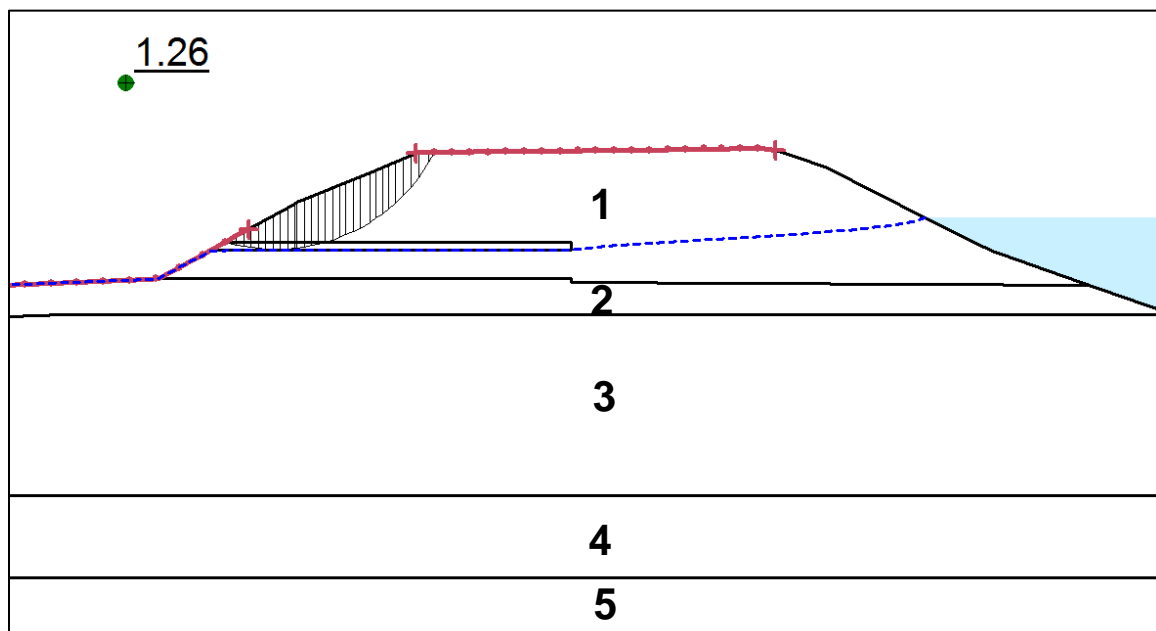
Figure 23. Stability Analysis Model - Burrow Hole on Landside Slope Located 1.5 ft. Below the Water Surface Elevation (Case 5)

- Underseepage analysis performed on the conceptual model resulted in an average vertical exit gradient of 0.5 at the levee toe. The calculated gradient meets criteria of 0.5 for underseepage (Figure 22).
- The factor of safety calculated from steady-state stability analysis was reduced from 1.74 (under a no-burrow condition) to as low as 1.26 (under a burrow on the landside slope at 1.5 feet below the water surface elevation condition) (Figure 23).
- Additional analysis was performed considering a burrow on the landside slope, located 1.5 feet below the water surface elevation. Seepage analysis performed resulted in increase in the break out point above the landside toe from 0.6 (under a no-burrow condition) to 1.7 feet (under a burrow on the landside slope at 1.5 feet below the water surface elevation condition) due significant reduction in the seepage path(Figure 22).
